City of Long Beach

JOHN A. MIRANDO, P.E.
COMMISSIONER
DEPARTMENT OF PUBLIC WORKS

RE: Long Beach Groin Failures

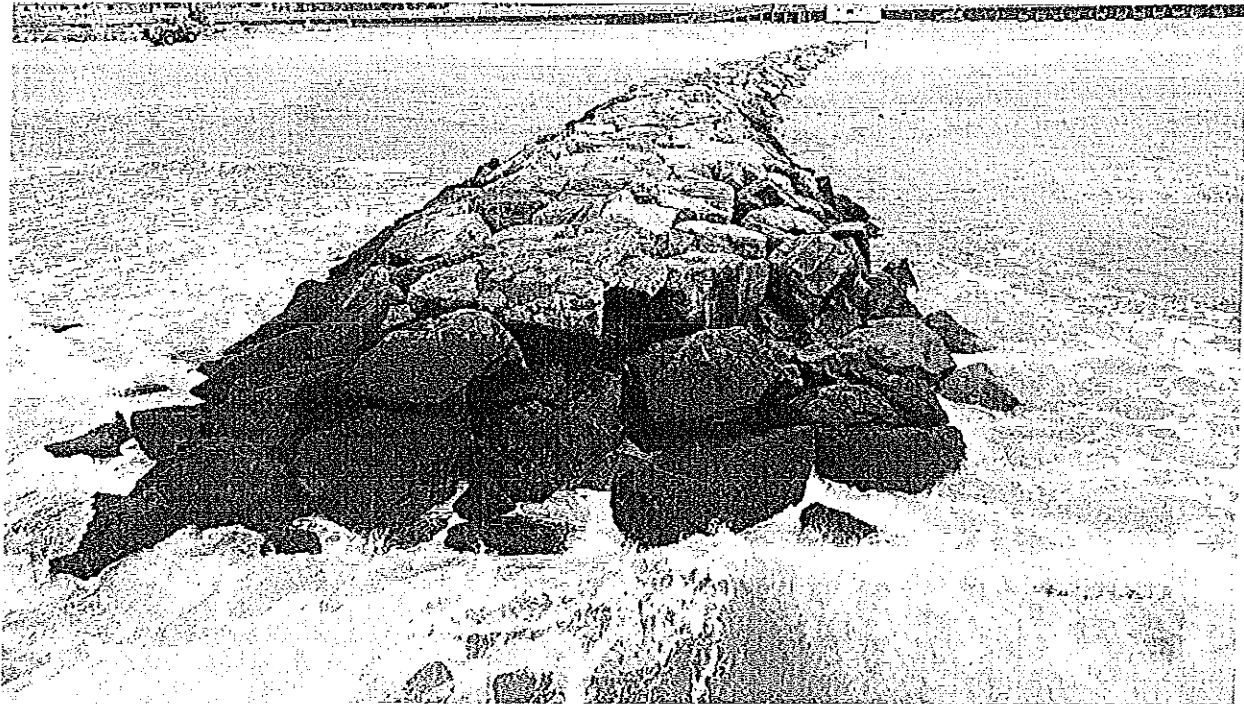
The photograph below of Groin 32 located on Grand Boulevard provides an example of the structural failure we have observed (Figure 1). From the photograph, it is apparent that armor

stone boulders on the seaward portion of the groin slope have slid seaward and down, resulting in separation along the top and east (right) side of the groin. Several factors can contribute to this type of failure, including the use of boulders of improper shape, size or weight, non-interlocking boulder placement, lack of adequate foundation for scour protection, and/or the lack of overall structural stability sufficient to combat wave activity.

Figure 1. Head of Groin 32 (courtesy of Shewen Bian)
